GRACE  
EPISCOPAL  
CHURCH  
NEWTON, MASSACHUSETTS

Tower Restoration Project  
Newton Community Preservation Program  
Funding Request  
August 14, 2020

<b>Project TITLE</b>	<b>Grace Episcopal Church Tower, Belfry, and Spire Restoration</b>		
↓ Check off submitted attachments here.			
<b>REQUIRED.</b>		<b>PHOTOS</b>	of existing site or resource conditions (2-3 photos may be enough)
		<b>MAP</b>	of site in relation to nearest major roads (omit if project has no site)
Pre-proposals: separate attachments not required, just use page 3 of form.  <b>Full proposals: separate, detailed budget attachments REQUIRED.</b>	<b>PROJECT FINANCES</b> printed and as computer spreadsheets, with both uses & sources of funds		
		<b>Development pro forma/capital budget:</b> include total cost, hard vs. soft costs and contingencies, and project management – amount and cost of time from contractors or staff (in-kind contributions by existing staff must also be costed)	
		<b>Maintenance budget, projected separately for each of the next 10 years</b> (CPA funds may not be used for operations or maintenance)

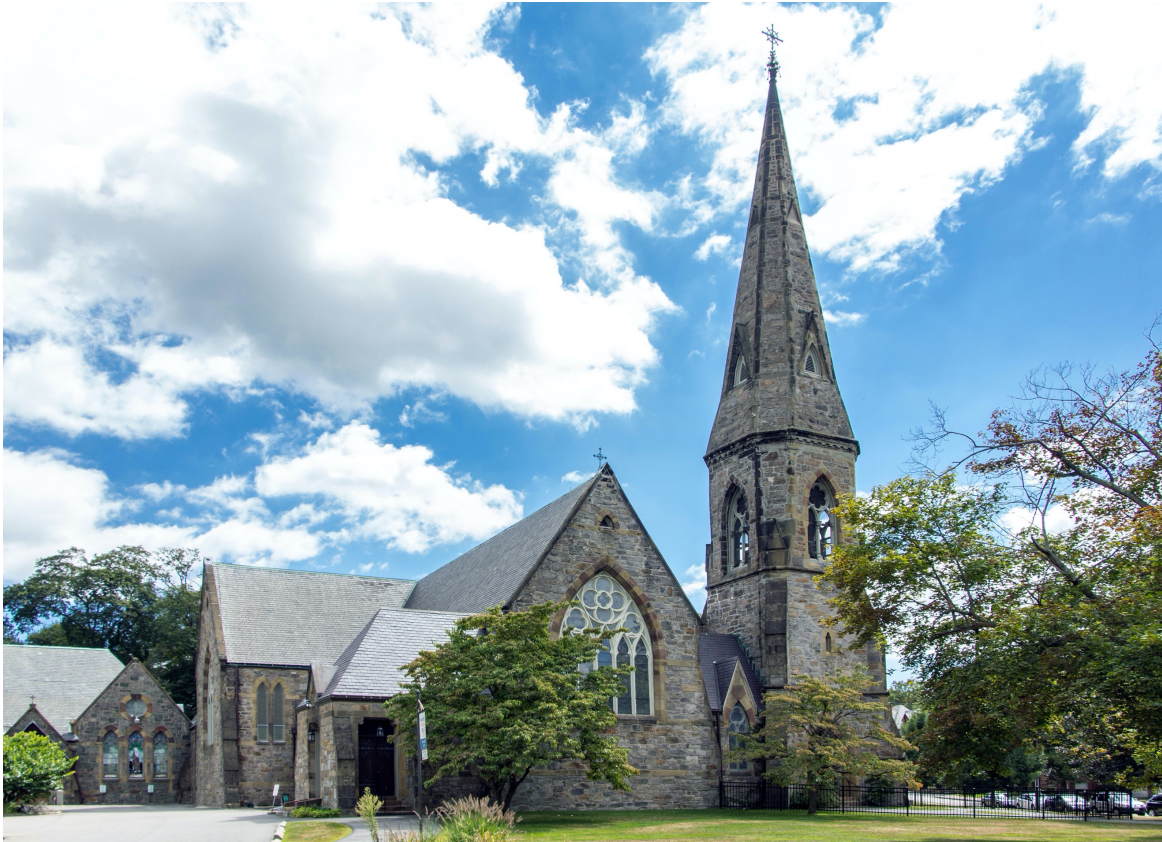
Grace Episcopal Church, Newton from Eldredge Street. Spring 2019.

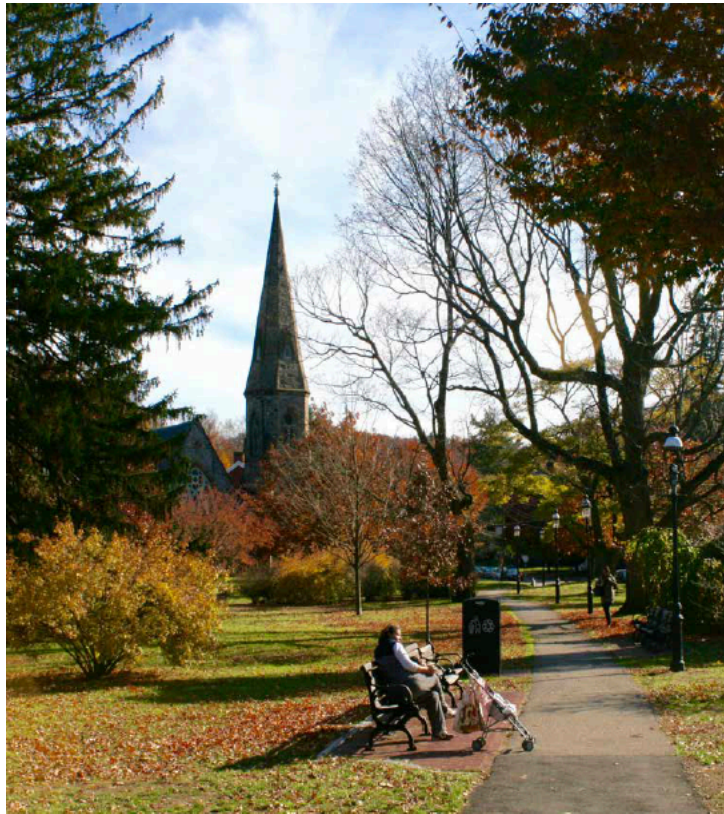
View of the Grace Episcopal Church, Newton-Tower from Farlow Park. Fall 2018.

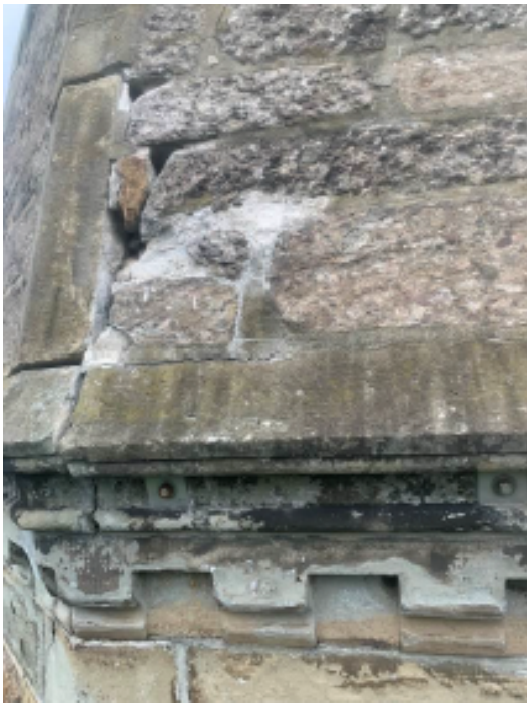
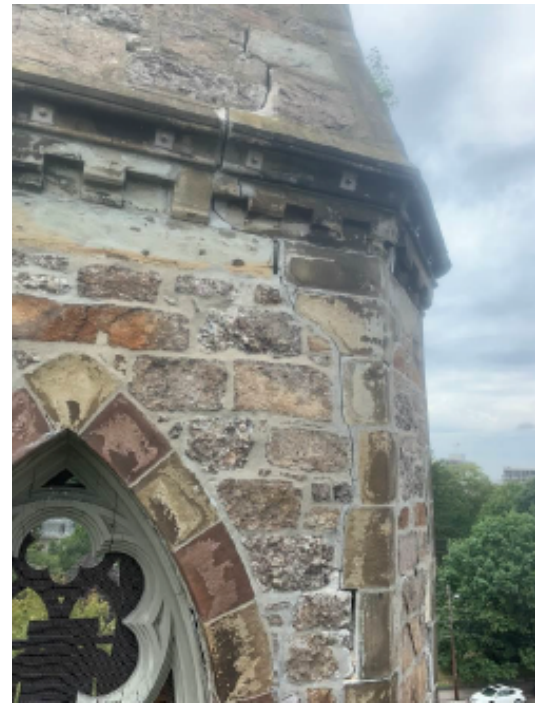
Examples of present Tower conditions. September 2019. Additional examples and full resource conditions report from Structures North available.

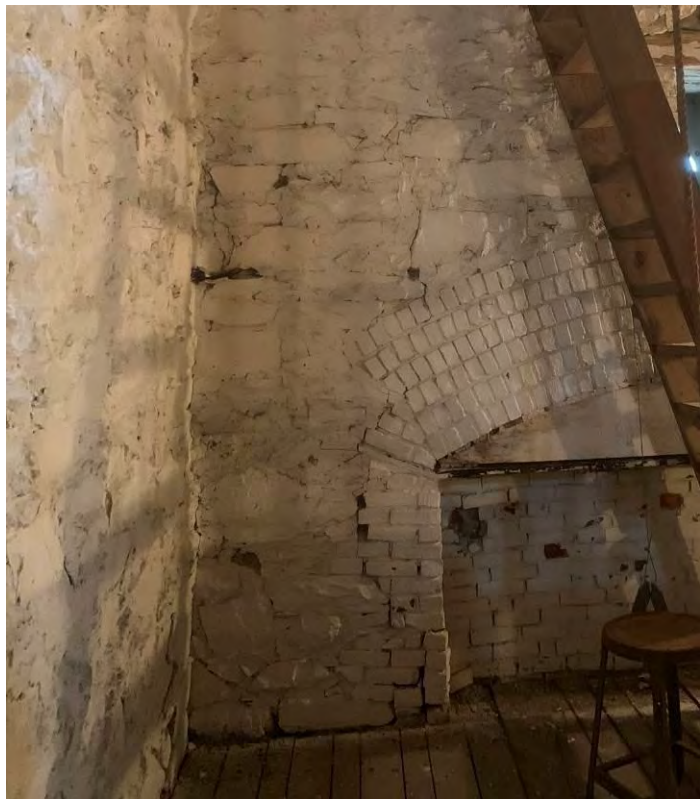
One potential cause of the cracking may be incompatibility between masonry materials such as when a tall structure is constructed as a composite of brick and stone. The tower at Grace has vertically stacked brick-lined openings surrounded by stonework that runs to the ground. Brick will swell with moisture and permanently expand whereas stone will not. When expanding brick structures such as arches and piers are surrounded by stone construction, the expansion can cause cracks and shifting

in the stonework. If the brick archways expand, their pointed tops will tend to split the surrounding stonework above the arches, and push outward and downward at their bases. This would be consistent with the damage that I observed within the masonry in these areas (as further described in this report). Fortunately these growths, which occur at the beginning of a structure's life, do not continue unless something elevates the moisture levels in the brickwork above previously ambient levels.

*The cracks should be jet-cleaned, surface pointed and then injected with grout. Consideration should be given to creating supplemental horizontal restraint within the tower, to resist the spreading that has allowed these cracks to occur.*

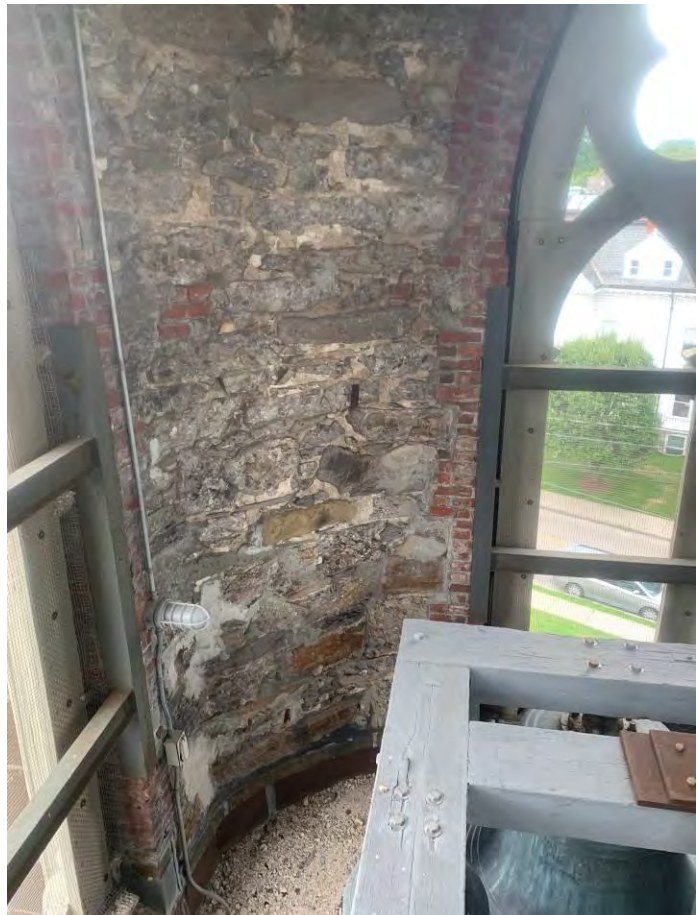
- 2011 Condition (2019 similar): The wooden louver tracery panel at the north wall has become detached from the masonry surround and has fallen

backward, toward the interior of the belfry. This has revealed a gap between the exterior stone trim and the brick arch in the back-up of several inches, where water can freely enter the interior of the wall construction. We expect the exposed, open gap in the stonework to be a primary source of infiltrating water.

*The tracery panel should be positioned back into place and be firmly fixed against future movement and the surrounding stone interface should be bridged with sealant. Consideration should be given to applying similar measures to all of the tracer panels to prevent the same damage from eventually occurring.*

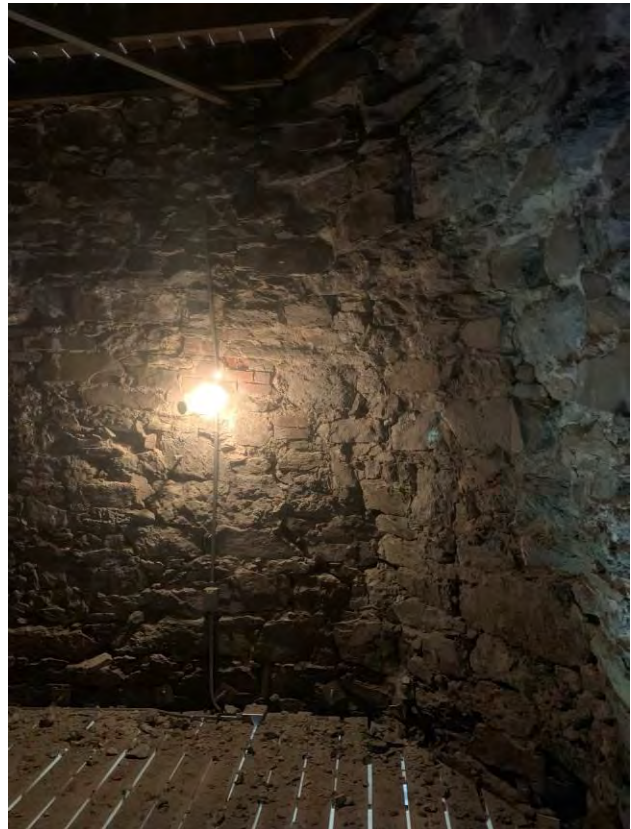
- 2011 Condition: There is a structural crack running upward through the north wall, generally along the angled facet from north to east. The stonework along this crack is eroded and some of it is loose.

2019 Condition: There is an additional crack running the northwest facet and vertical cracks at the east edge of the south wall face and the upper portion of the southwest facet.

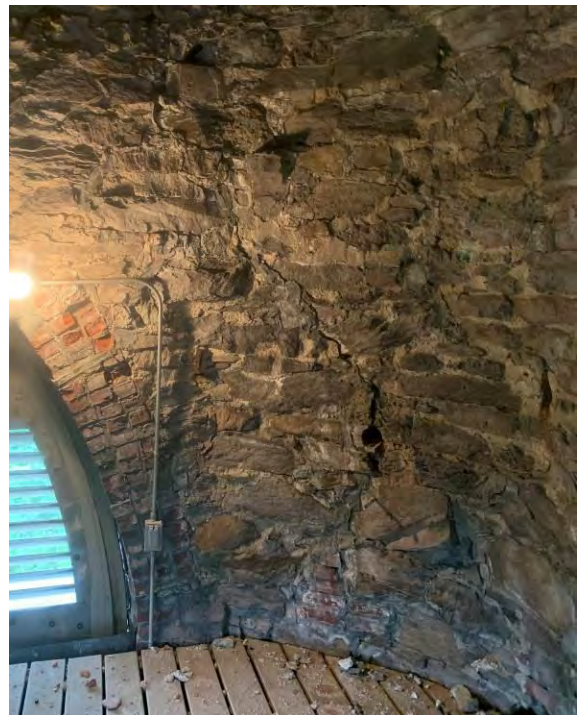
- 2011 Condition (2019 similar): Much of the exposed interior stonework within the spire has eroded mortar joints, and there are repeated vertical cracks running throughout the interior stone surfaces. *This is consistent with what has been seen below, within the tower, and should be treated in a similar fashion.*
- 2011 Condition (2019 similar): The brick arch on the south side of the tower is crumbling and a crack runs along the top of it. *The upper portions of the arch should be reconstructed.*
- 2011 Condition (2019 presumed similar) Water is leaking out of the core hole drilled into the north face of the spire. This water seems to be coming from within the interior of the wall construction, having traveled within internal pathways after entering through open joints and stone defects on the exterior. *Water infiltrating the exterior should be eliminated at its source.*

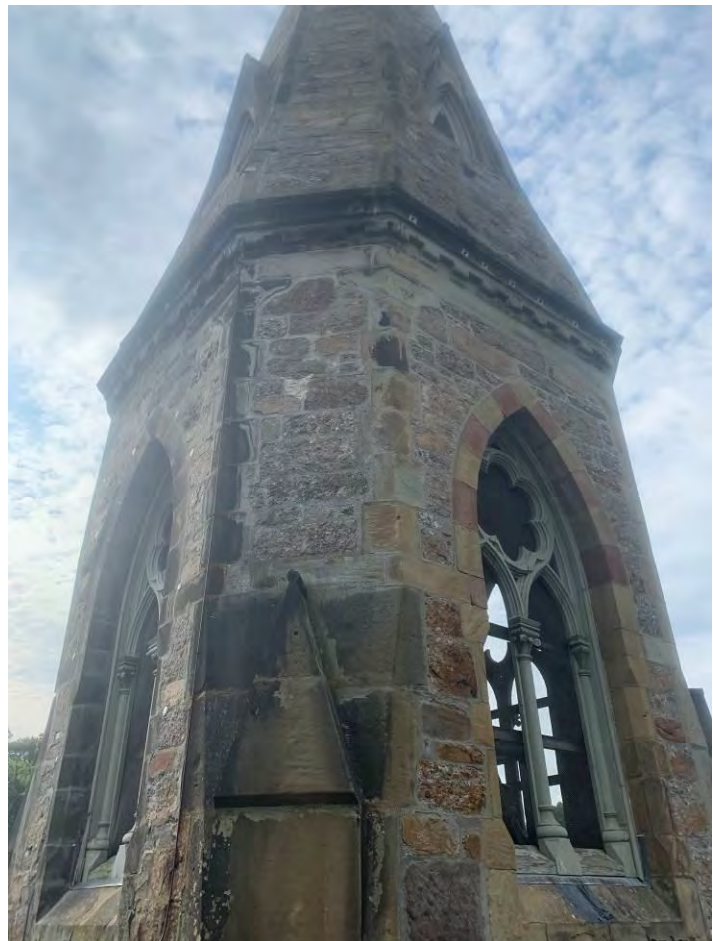
*Ideally the entire tower should be cut and repointed, however a spot pointing that addresses the most critical areas would be sufficient at this time. Cracked joints should be investigated as to the causes of the cracks, which in most cases are from displacement of the masonry units and of the structure itself (please see below). Where units are not to be re-set, cracks should be jetted clean with water, surface pointed, and the injected with pozzolanic lime-based grout.*

*Cracks in individual ashlar stone units, mainly those that are not to be removed, repaired off-site and re-set, can also be cross-pinned and injected with a variety of cement-based or adhesive-based stone restoration products.*

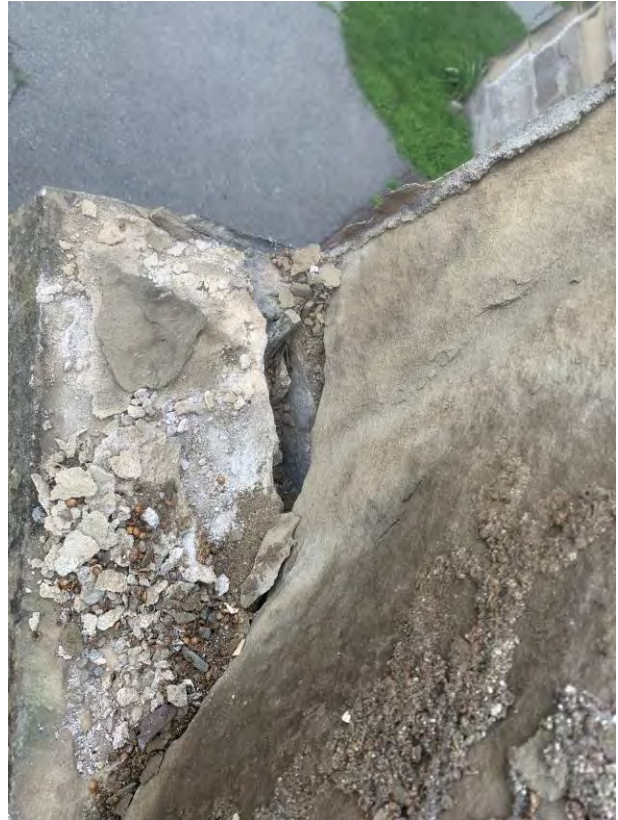
- The lower portion of the southwest buttress has a severe longitudinal crack running through its south face, which is indicative of internal deterioration, *and must be rebuilt.*
- The upper portion of the northwest buttress has a longitudinal crack running through its south face, which is indicative of internal deterioration, *and must also be rebuilt.*
- One of the shingle stones at the southeast buttress's lower step has split nearly in half due to a deep crack and spall. *For safety sake we removed the loose piece, which unfortunately revealed a gap below it which let more water into the masonry if not repaired. The removed piece was retained on site for reattachment.*

*Buttress rebuilding consists of dismantling and reconstructing these elements with the addition of internal stainless steel ties that prevent them from spreading in the future. It may be that some of the vertical cracking within the tower has been allowed in part to the shortening of the buttresses, which is evident through the cracking and outward buckling movements that have occurred in the stacked quoins and shingle stones.*

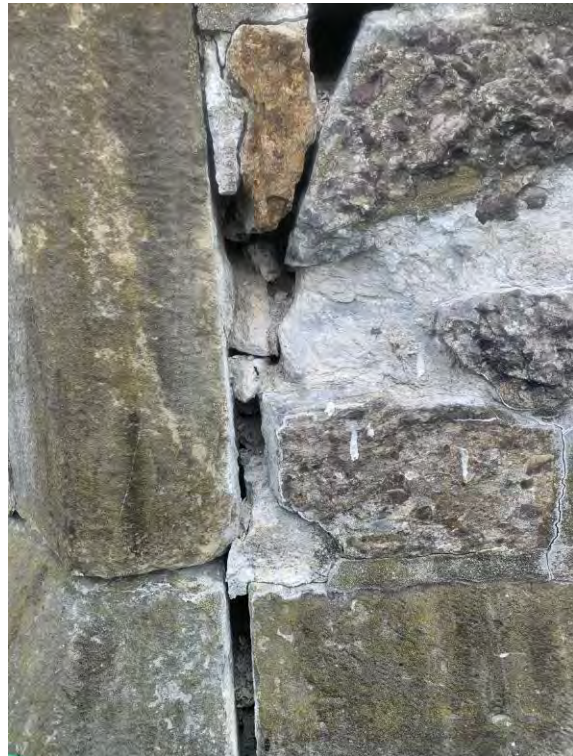
- 2011 Condition: There is an open gap at a head joint at the north end of the line of sill stones that run below the east belfry opening. There is also another open head joint further to the north where ashlar construction meets the small gablet construction at the top of the northeast pinnacle, and many of the repointed head joints between these and above are unusually wide, suggesting that a net horizontal spreading in the stone masonry has occurred.

At about the north spring point of the belfry arch starts an open crack between the east face of the tower and the northeast facet, angling southward and then running up and through the stone band that rings the base of the spire and continuing beyond. Please see “*Spire Base*”, below.

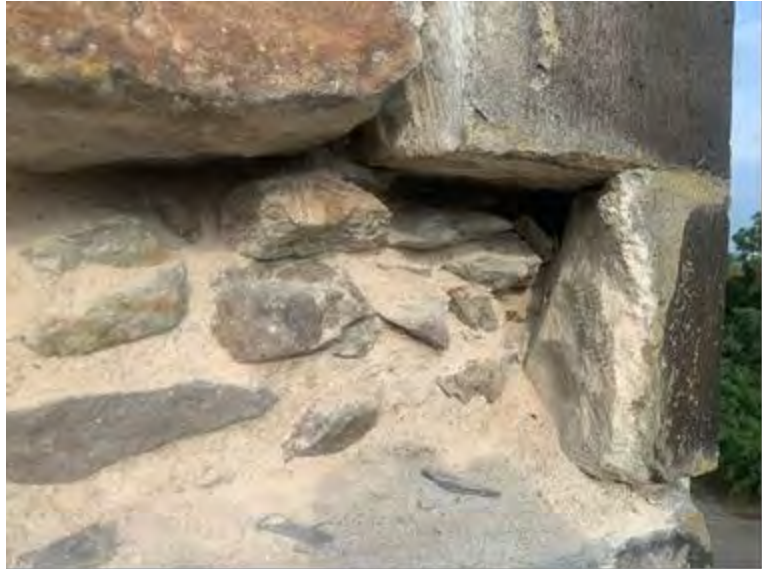
- Multiple large vertical cracks within the masonry to the east of the north belfry opening and within the northeast facet. These cracks continue upward into the flared spire base.
- A large crack running upward from the head of the north belfry opening, up into the string course at the bottom of the flared spire base.
- Looking into the above-noted holes, I could see a semi sand-filled void within the collar joint behind the exterior stonework, and then a more solid masonry core.

The fact that these widened head joints are at the same general location where the tower is experiencing the most water infiltration is logically consistent. If the joints are widened at the exterior, they are also widened at the interior, where pathways are being created within the masonry that transport and hold water which cyclically freezes and thaws within this unheated structure, expanding the masonry even more. This is also the area where the stonework is in the worst condition at the interior, and in need of partial reconstruction. Considering the differences between the 2011 and 2019 observations, conditions are clearly becoming worse as no significant attempt has been made to stabilize the tower masonry within the last 10 years.

*With large mass of stonework involved and the heavy overburden of the spire above it, full reconstruction is not a reasonable option. Rather, sequential excavation, removal and re-setting of unsound masonry material from both the interior and, where practical, from the exterior, along with injection grouting of inaccessible masonry in the center should restore the affected areas to a stable condition. Where exterior stone units are too large to re-set or reposition, the widened joints between should be chinked with slate or sawn granite sheets in order to minimize the width of the mortar in the joints, thus reducing shrinkage and increasing the durability of the joints. Please see additional recommendations under "Exterior/ Spire Base" below.*

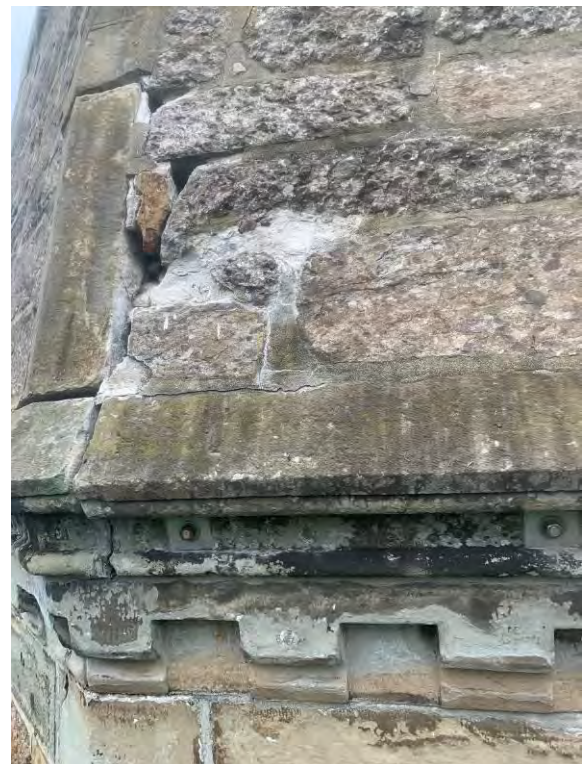
- 2011 Condition (2019 similar): There is a line of exposed stainless steel rods and anchor plates that pass through the stone spire base band, running all of the way around the tower. These appear to have been an attempt to resist radial thrusts in the masonry that are the likely cause of the above-noted separation.

Because the base of the spire flares outward and the gravity loads within the spire walls follow the sloping planes of the walls, the outward and then sudden inward change slope at this level, tangential forces result each slope change at the point of each

bend. While the interior surface of the spire does not actually flare (rather the walls thicken at the base to create the flare), the outside surfaces still do, and depending upon the quality of internal bonding in the wall construction, the spire base either acts as a composite thickened element, or an un-flared wall “leaf” element at the interior and a flared wall “leaf” element at the exterior, confining a debonded rubble fill between them.

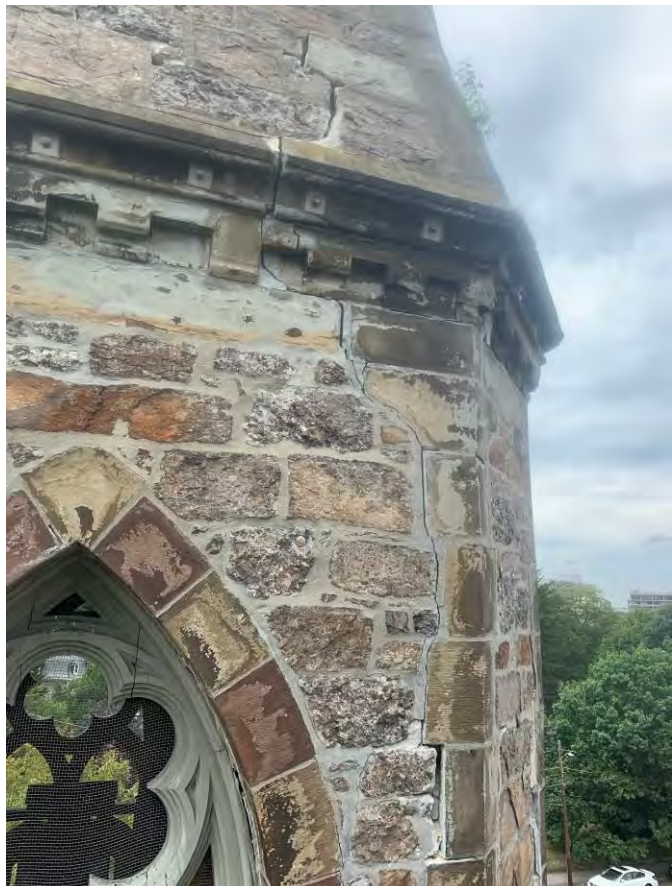
- 2011 Condition (2019 Condition similar but more severe): The above-noted crack that runs up from the north corner of the belfry arch crosses vertically through the base of the spire and then appears to angle back out toward the edge of the northeast facet and then follows the line of quoins upward past the small dormletted louver. Sighting from a distance, one can see a clear separation and outward movement of the spire

base here, occurring over the entire width of the spire's northeast facet, which turns the corner to the north face of the tower.

The cracking, apparent separation and bulge are a clear indication that the flare is behaving in a two-leaf manner. While the horizontal bolts may do an adequate good job of tying the leaves together, they do not resolve the outward thrusts at this level on the tower.

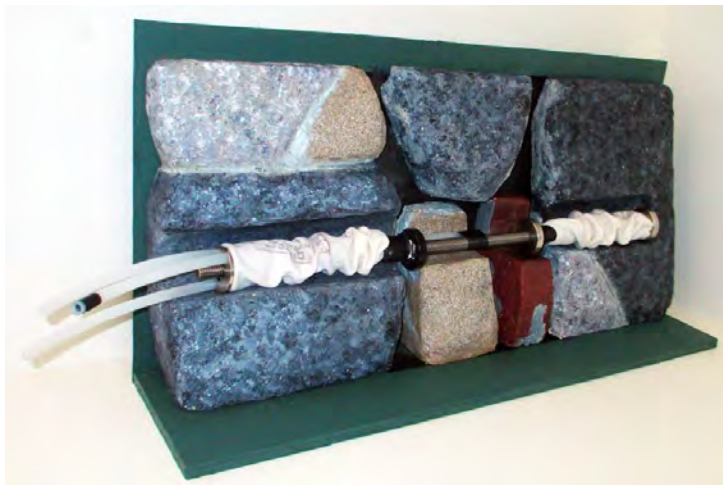
The most alarming condition noted in our 2019 survey is apparent outward separation and unrestrained movement of the northeast corner of the flared base, which is noticeably worse than it was in 2011. If conditions continue to progress without intervention the tower will reach a point of global instability.

*While there is a network of rods crossing the tower at top and bottom of this level at the interior, these appear to be anchored into the interior masonry core and not the outer stonework where the thrust is actually taking place. Spring-loaded tension frames installed above and below the floor of the spire level would provide*

*sufficient additional restraint to counter the outward thrusts if combined with an integral tying system that engages the outer masonry and could prevent further load related cracking in the stonework.*

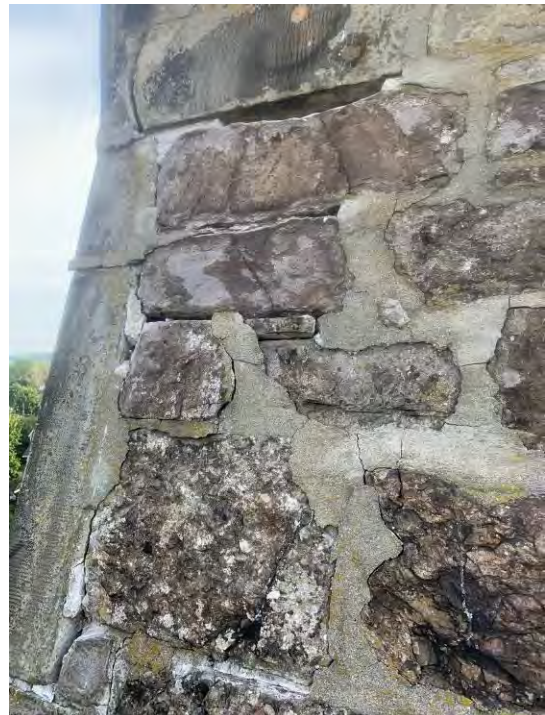
The irregularities and cracks are indications that the outer leaf of stonework, particularly the quoins and isolated elements of the ashlar stonework, have separated from the back-up portions of the walls.

Entire sections of quoin stones are bulging outward at the north northeast aris, north northwest aris, the south southwest aris, and the south southeast aris.

*We recommend locally and sequentially removing all shifted stone elements, excavating and restoring the back-up construction, and then reinstalling the removed stone units using hidden stainless steel ties to the back-up construction to prevent future separation. There will be the chance that some areas of the back-up will be in such poor condition that the excavations may go all of the way to the interior, and require full thickness rebuilding.*

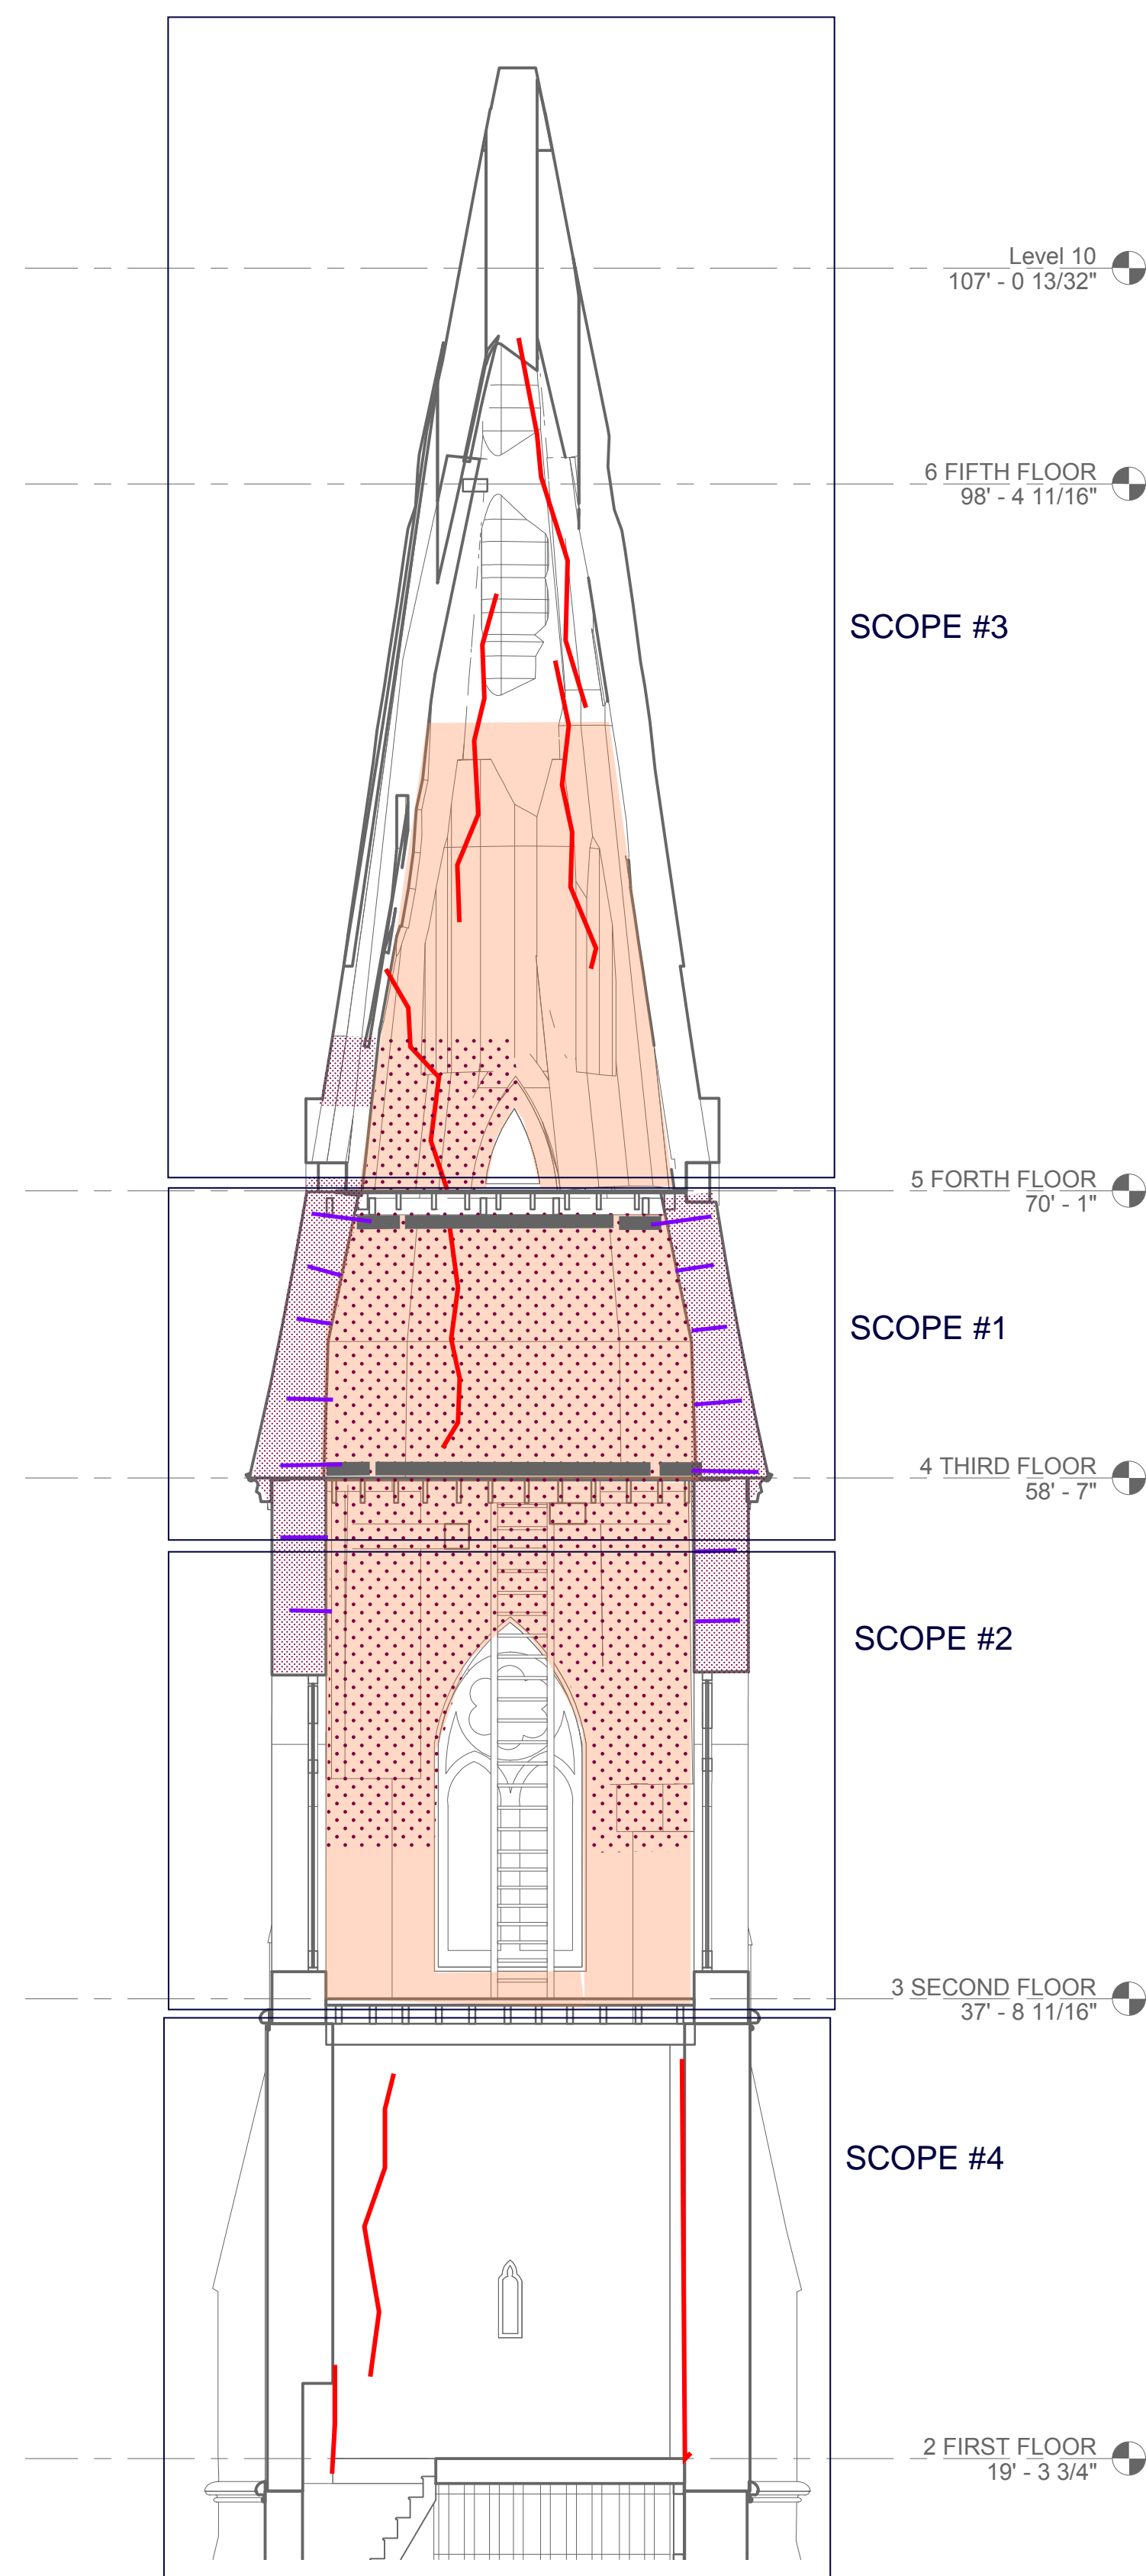
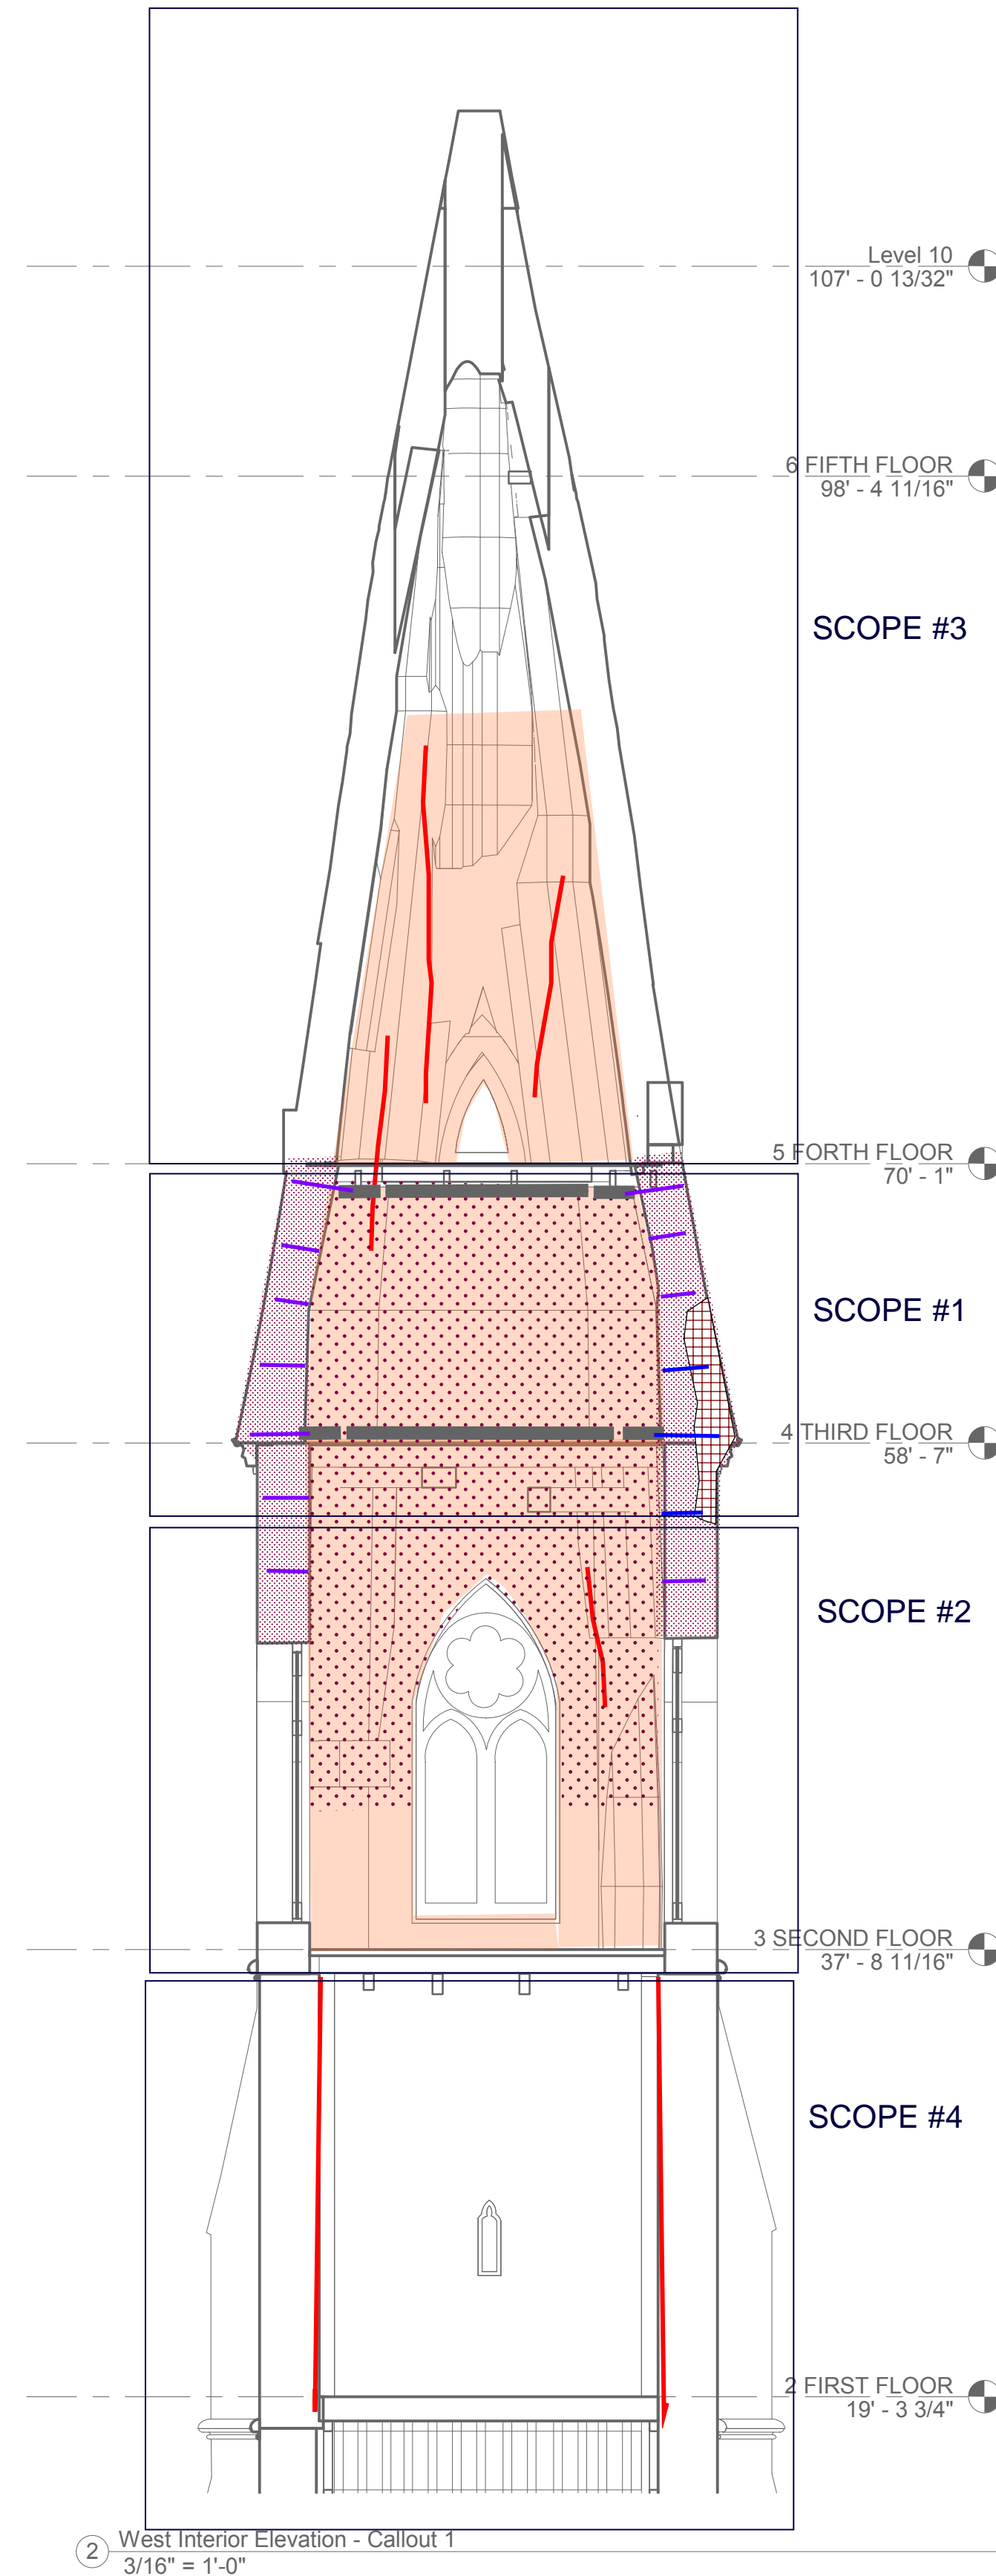
| | SPRING-LOADED GALVANIZED STEEL TENSION RING FRAME w/ PORT ANCHORS TYING INTO IT |
| | DEEPLY CUT AND POINT EXPOSED STONEMWORK |
